EXISTING EXTERIOR CONDITIONS AND ASSESSMENT REPORT
FOR

BUILDING 2 MAIN BUILDING

**CLEMENT J. ZABLOCKI
VA MEDICAL CENTER**
MILWAUKEE, WI

November 16, 2012

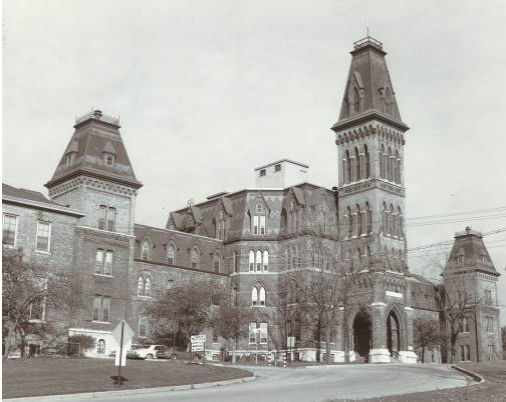
Image shows discoloration of the Cream City brick. Main Building, ca. 1980's, VAMC Archives.

Based on photographic documentation, it appears that the building was cleaned in the 1970s or 80s, likely by sandblasting. Sandblasting is not a recommended cleaning method for masonry, since it can remove the hardened baked face of the brick leaving a very soft and porous surface that is highly susceptible to freeze-thaw. Fortunately, it does not appear that this has become a serious issue on the building at this time.

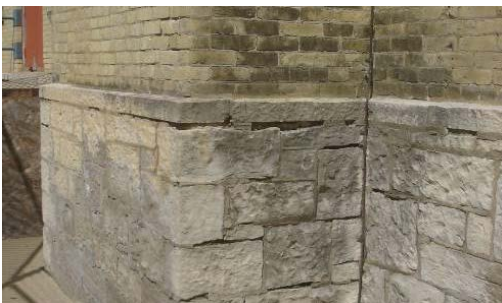
Surface staining, stone erosion, and mortar joint deterioration.

Overall the masonry is in fair to good condition with minor areas of atmospheric dirt and/or biological growth, mortar joint repointing, and brick or stone replacement required.

For masonry areas that require cleaning, it is recommended they be cleaned with the gentlest means possible, starting with a mild detergent and progressing up to a diluted acidic wash. For areas with biological growth, it is recommended that all growth be removed prior to cleaning.

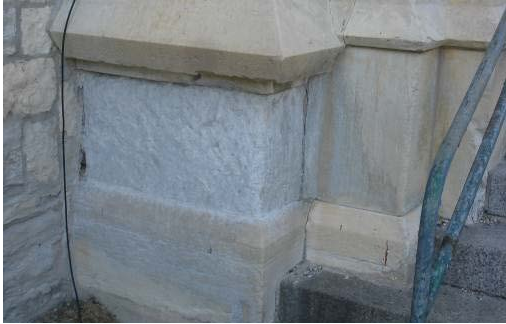
Spalling stone at the main entry on the east elevation.

There is stone deterioration around the building including surface degradation and spalling, cracking, and displaced or missing stone. It is recommended that the stone be repaired or replaced as required. It is also recommended that the future use of de-icing salts be restricted from being used adjacent to masonry surfaces. Other areas of surface degradation are likely caused by water run-off. The sources should be determined and corrected prior to masonry restoration.

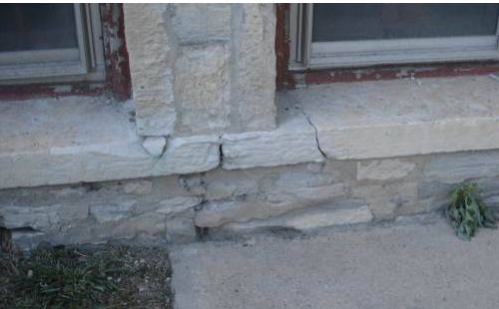
Cracked stone sill at lower level windows on the east elevation requires repair.

There are miscellaneous areas of cracked stone, mostly at the window sills around the building. It is recommended that the sills be repaired in-place using stainless steel pins and patched using a masonry-patching product such as a Jahn or Edison Coatings.

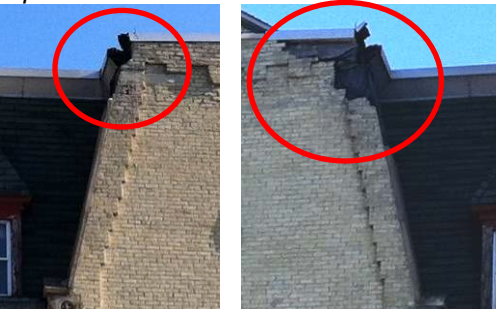
Missing brick and stone cap occurs at both the east and west sides of the mansard-profiled wall at the center of the south elevation of the A-Wing.

Chipped, eroded, and/or spalling brick appear to be isolated to areas where the mortar joints are severely deteriorated. Bricks should be replaced if severely eroded or missing. There are areas of missing brick and stone caps at the tops of the walls at numerous locations. When masonry work proceeds, it is recommended that all of the metal caps be removed and the stone inspected for deterioration, repaired, and/or documented and replaced in kind if needed. Exposing the stone parapets would represent the historical appearance more accurately. Horizontal mortar joints are highly susceptible to weathering, so the installation of metal T-inserts set in a bed of sealant in the horizontal joints on top of the wall would provide additional protection.

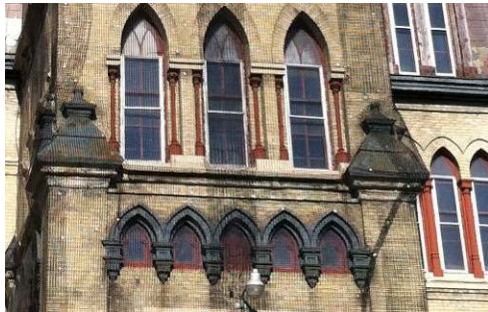
Decorative metals at the main front (east) entry.

The metal appears to be in fair to poor condition. All rust and scale should be removed from the metal at all locations, repairs are to be made as required, and the metal be refinished to match its historical appearance.

It is unknown how the metal is anchored into the masonry; and while there is no direct evidence of deterioration visible from the exterior at this time, it is recommended that it should be investigated to ensure they remain sound.

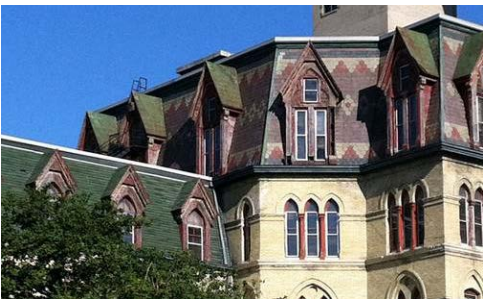
Tri-colored slate shingles.

The five towers on the A-Wing and the perimeter of the main building have mansard profiled roofs covered with tri-color decorative patterned slate, with the exception of the northwest corner tower which is a single color. The slate is in poor condition.

- **Roofs**
 - 100% Slate shingle replacement with slate (or simulated slate) shingles.
 - 100% asphalt shingle replacement with slate (or simulated slate) shingles.

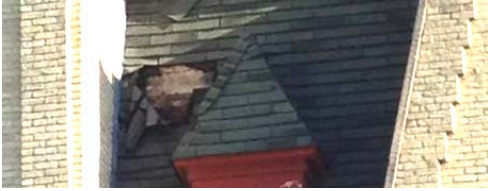
Asphalt shingle deterioration at the south elevation is exposing the wood roof decking below.

also in poor condition.

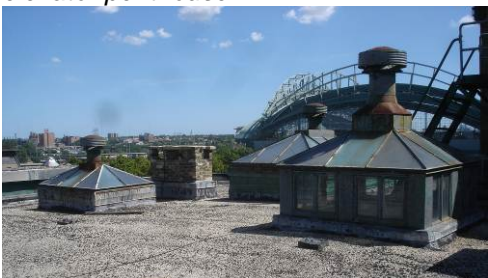
Roof skylights, or light monitors, on the low-sloped area of the A-Wing. Metal vents are incorporated into the metal framing.

There are metal-framed skylights or monitors that have both translucent glazing and wired translucent glazing. It is unknown if these date from the building's Period of Significance, and that should be determined. If they are to be retained, the glazing compound should be tested for asbestos, and all of the glazing compound should be removed and replaced.

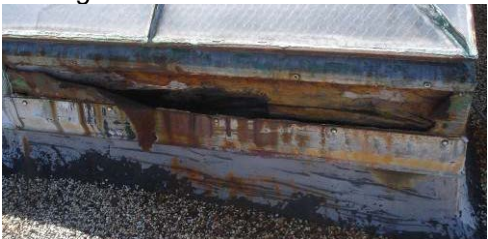
Example of deteriorated counter flashing on the skylight.

The skylights' metal framing appears to be in fair condition, while the metal counter-flashing ranges from poor to fair condition. If the skylights are to be retained when roof work proceeds, it is recommended that all of the flashing be replaced, any scale and rust be removed from the metal framing, the metal repaired as required, and refinished to match the historical appearance. An alternative to repair would be replacement. If units are damaged beyond repair, replacement in a manner consistent with the Secretary of the Interior's Standards could be an option.

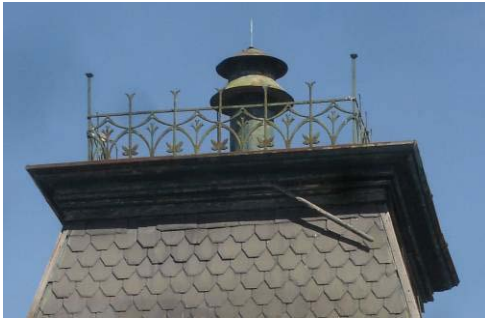
Typical metal cresting at towers.

There is decorative metal cresting around the perimeter of all the mansard tower roofs, with the exception of the main entry (east) tower, which was replaced at an unknown date with simple horizontal rails. The cresting appears to be exhibiting similar finish deterioration as the other decorative metal on the exterior. All cresting should be repaired and refinished as required to match the historical appearance.

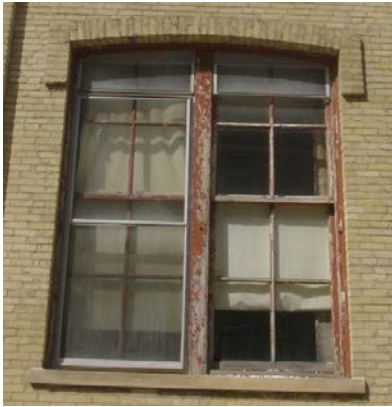
Example of paired windows with true divided lites and wood mullion.

All of the original single-glazed, true divided-lite, double-hung, wood windows remain intact within their original openings with non-original aluminum storm windows. It is unknown if there were originally wood storms and screens, and additional research should be conducted to determine if there were and what their profile would have been.

The wood sash, muntins, and trim all appear to be in good condition considering their age. It is recommended that all of the windows be restored and refinished where possible. Glazing compound should be tested for asbestos before replacement.

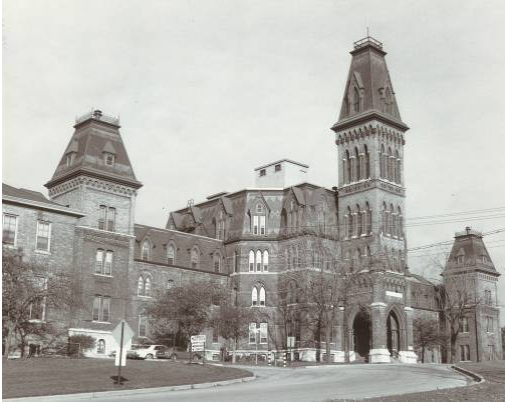
Image shows discoloration of the Cream City brick. Main Building, ca. 1980's, VAMC Archives.

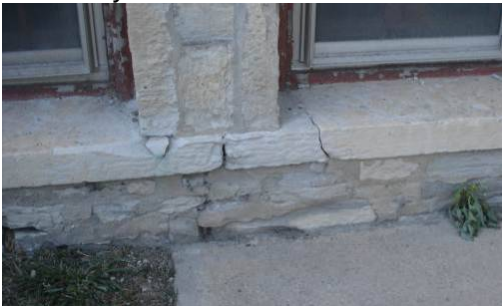
Cracked stone sill at lower level windows on the east elevation requires repair.

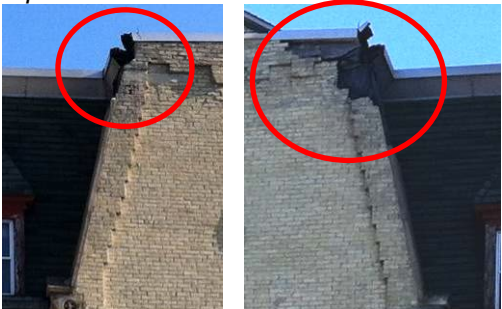
Missing brick and stone cap occurs at both the east and west sides of the mansard-profiled wall at the center of the south elevation of the A-Wing.

There are areas of missing brick and stone caps at the tops of the walls at numerous locations. Most notable is the degradation at the upper corners of the mansard profiled walls in the center of the south and north elevations of the A-Wing. A common cause for deterioration at the top of masonry walls is the failure of horizontal joints. This then allows moisture to enter the top of the wall and cause damage through freeze/thaw action. The masonry parapets at the roof have also been covered with metal, which may have been a solution to covering deteriorated joints and masonry. When masonry work proceeds, it is recommended that all of the metal caps be removed and the stone inspected for deterioration, repaired, and/or documented and replaced in kind if needed. Exposing the stone parapets would represent the historical appearance more accurately. Due to horizontal mortar joints being highly susceptible to

weathering, the installation of metal T-inserts set in a bed of sealant in the horizontal joints on top of the wall would provide additional protection.

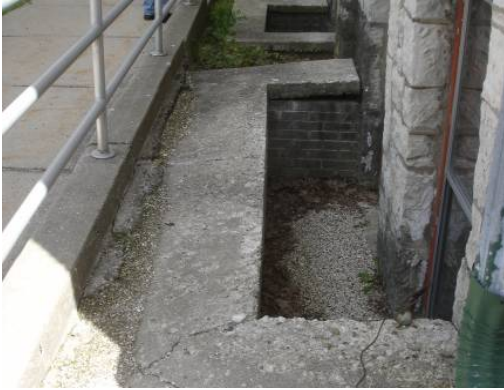
Masonry lined window wells at the north side of the B-Wing.

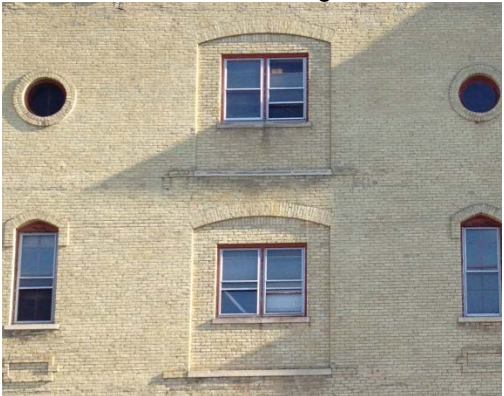
Infilled masonry openings at the south elevation of the A-Wing.

There are large infilled masonry areas on both the north and south sides of the A-Wing. It is assumed that these were previous openings onto the exterior porches that are visible in some of the historic images. Depending on the potential reuse of the building, and the VA's desire, restoring this to their original historic appearance could be explored.

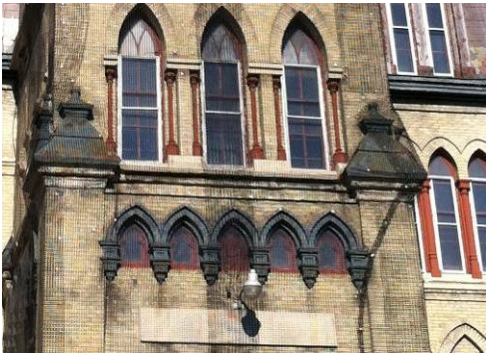
Decorative metals at the main front (east) entry.

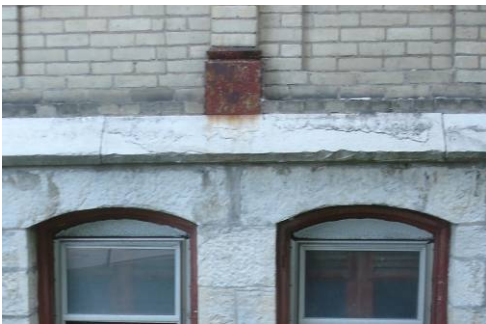
Rust blooming at metal pilaster base and staining stone below.

- **Decorative Metals**
 - Decorative metals embedded within the masonry should be evaluated to ensure that anchorage details are sound.
 - All metal should have any scale and rust removed and be refinished to match the historical appearance.

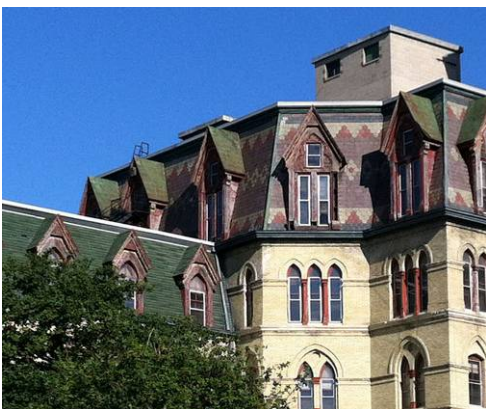
Tri-colored slate shingles on the mansard roof. The slate has been replaced with green colored asphalt shingles on the left side of the image above.

The corner towers of the A-Wing, main front (east) entry tower, and the perimeter of the main building have mansard profiled roofs. These mansard-style roof areas are covered with tri-color decorative patterned slate with bands of square butt-end slate and bands of gothic style butt-end slate. The northwest corner tower has been likely re-roofed with a single color gothic butt end slate. The slate in all areas is in poor condition with many missing and loose pieces.

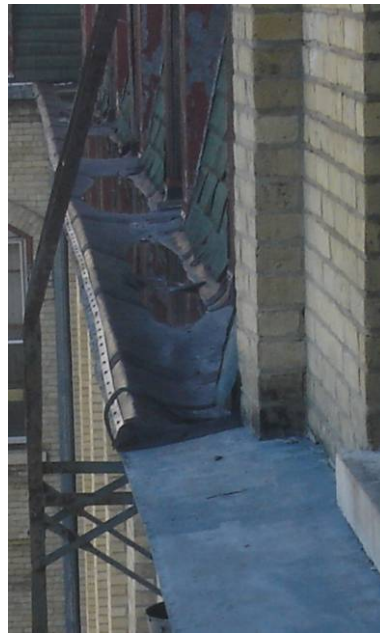
Along the base of the mansard roofs where there is little or no positive slope to the ledge below, the top surface has been covered with EPDM terminated at the perimeter with termination (term) bars. The term bars are not in good condition and the seams in the EPDM are deteriorated. This ledge at the base of the roof transitions to a painted metal sill where very little of the paint finish remains and building debris is collecting.

EPDM at the base of the mansard roof transitions to a painted metal sill.

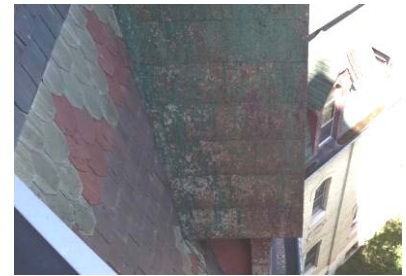
Example of typical degradation of the terne metal shingle roofs above the dormers.

Repair any deteriorated wood associated with the roof including: cornices, eaves, soffits, and dormers. Missing wood, or wood beyond repair, is to be replaced to match the existing species and profile. All bare wood is to be treated with a wood preservative and finished to match the historical appearance. Any new wood is also to be back-primed.

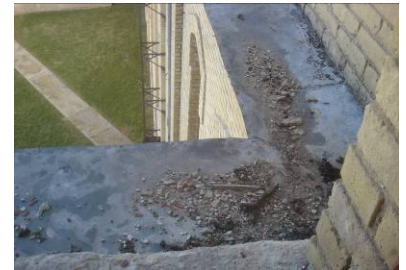
Deteriorated paint finish at the metal sill and collecting building debris.

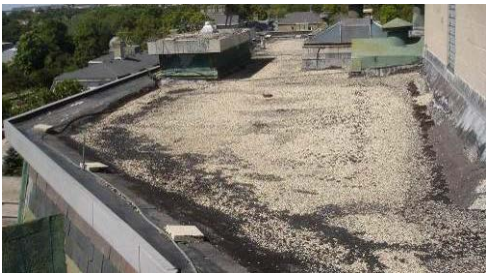
Low slope roof to the south of the elevator penthouse.

The low-slope roof areas consist of built-up roof systems. These roofs are in extremely poor condition and have surpassed their intended life expectancies. There are areas where “blisters” have formed and the built-up membrane is no longer sufficiently adhered to the roof deck. There is also visible degradation of the membrane at the roof perimeter where the aggregate surfacing has been redistributed by weathering.

100% removal and replacement.
Approximately 350 squares.

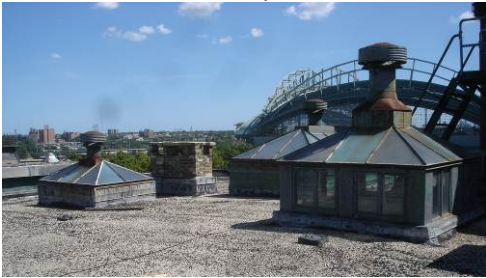
Roof skylights, or light monitors, on the low-sloped area of the A-Wing. Metal vents are incorporated into the metal framing.

There are metal framed skylights or monitors on the low-sloped roof of the A- and C-Wings. The skylights have both translucent glazing and wired translucent glazing. The glazing is in fair condition with a few broken panes of glass. The glazing compound should also be evaluated for weather tightness and tested for possible asbestos. To increase the longevity and enhance thermal performance of the skylights, all of the glazing compound should be removed and replaced.

The metal framing appears to be in fair condition with areas of rust where there is paint degradation. The metal counter flashing on the skylights ranges from poor to fair condition with some areas showing significant signs of deterioration and rust. When roof work proceeds, it is recommended that all of the flashing be replaced, any scale and rust be removed from the metal framing, the metal repaired as required, and refinished to match the historical appearance.

For Character-Defining Skylights: Repair any deteriorated skylight framing, replace any broken glazing and all glazing compound, and replace the flashing around all skylights.

For Non-Character-Defining Skylights: Replace with units that meet the Secretary of the Interior's Standards.

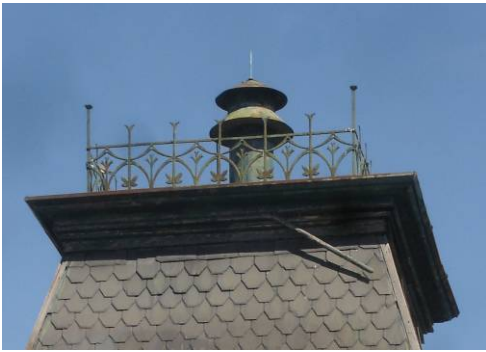
Typical metal cresting at towers.

The metal cresting at the roofs was visually evaluated from a distance and appears to be exhibiting similar finish deterioration as the other decorative metal on the exterior. All cresting should be repaired and refinished as required to match the historical appearance. It is also unknown how the cresting is fastened to the roof. Based on another building at the site that has a similar cresting detail (Building 6 – the original hospital building), the cresting was set atop wood 2xs that were not securely fastened to the roof structure and are floating above the roofing membrane. As restoration of the exterior proceeds, the cresting anchorage detail should be designed to ensure that it is adequately fastened to the roofing system.

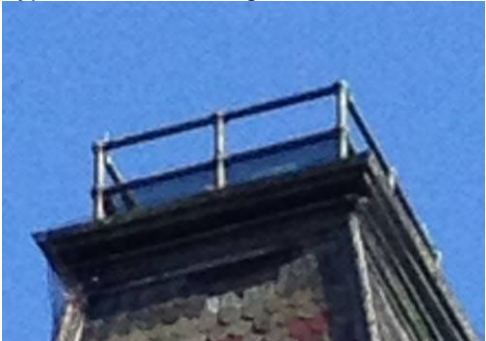
Metal rail at the perimeter of the main front (east) entry tower.

There is decorative metal cresting around the perimeter at the top of all the mansard tower roofs, with the exception of the main entry (east) tower which was likely replaced at an unknown date. The main tower has simple metal rails; however, based on historic images it appears a more decorative element was once present. As restoration of the building proceeds, it is recommended that additional research be performed to replicate what the cresting at the main tower was in order to match its historical appearance.

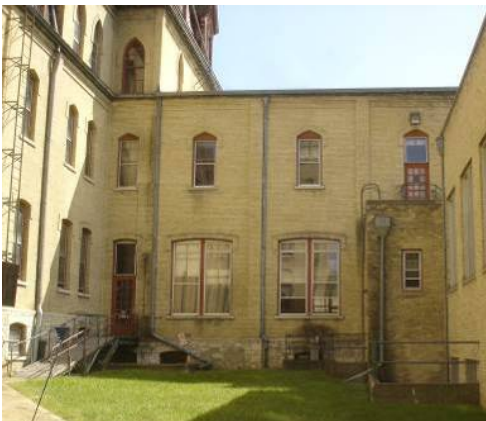
Gutters, scuppers and downspouts either drain directly at grade or into a below grade piping system.

All of the drainage for the building is handled by exterior gutters, scuppers, and downspouts. There do not appear to be any interior drains. Some of the downspouts drain directly on the ground a few feet from the building, and there are several others that tie into a below-grade piping system. Many of these older below-grade drainage systems were tied into the sanitary water system, which may or may not still be the case here. We recommend that the entire roof drainage system be designed to carry water immediately away from the building. Where drains are underground, they should be tested to make sure they are open, free flowing, not connected to the sanitary sewer system, and not allowing water to enter the building basements.

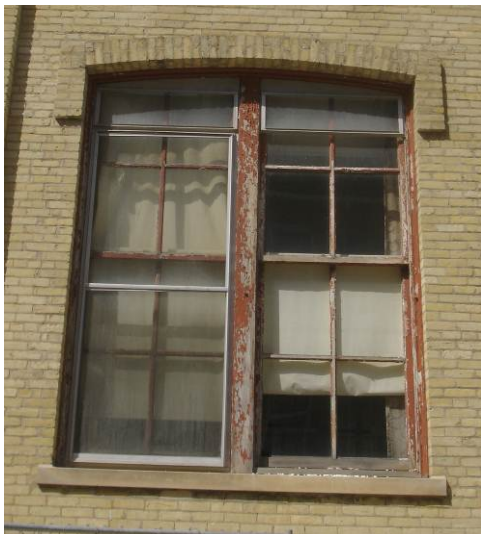
Paired windows with true divided lites and wood mullion are present on the B- and C-Wings.

It appears that all of the original single-glazed, true divided-lite, double-hung, wood windows remain intact within their original openings. There are a variety of profiles around the building, ranging from squared-within-squared openings, squared-within-round-arch openings, and pointed-gothic-arch openings. Squared aluminum storm windows were also installed at an unknown date and are not original to the building.

The wood sash, muntins and trim all appear to be in good condition considering their age. There is minor to moderate wood degradation evident at isolated areas such as sills, where moisture may not be shed quickly. The protective paint finish has worn away from the majority of all of the wood surfaces, and it is recommended that all of the windows be restored. Further investigation is required to determine how the glazing is set within the sash. Based on the age of the windows, it is possible that there is a wood stop; however, it is also possible that glazing compound was used

Restore all wood windows by repairing any deteriorated wood with consolidants or Dutchmen. Missing wood, or wood deteriorated beyond repair, is to be replaced to match the existing species and profile. All wood is to be treated with a wood preservative treatment and refinished to match the historical appearance. Any missing or broken glazing is to be replaced. All glazing compound is to be removed and replaced. Windows that can be shown to be beyond repair shall be reviewed with the architect for consideration of replacement with units to match the original.

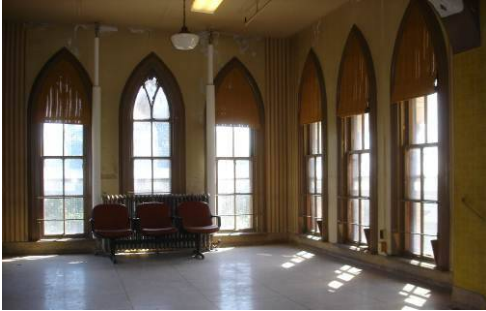
Windows within the entry tower are set 4 to 6 inches above the interior finished terrazzo floor. There are also remnants of draft guards present at the window stools.

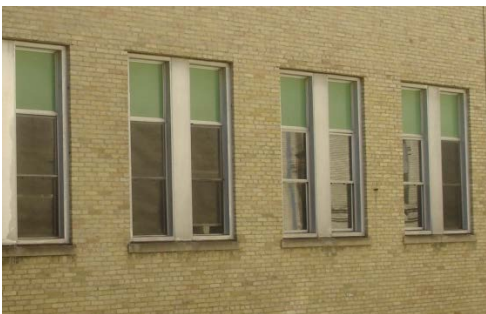
Windows on the C-Wing with aluminum storms and mullions.

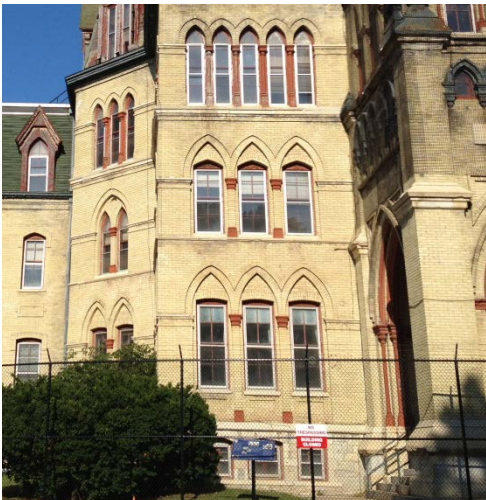
Window opening sizes and profiles vary on the east elevation of the A-Wing.

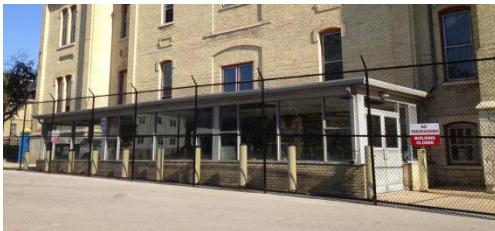
Entry vestibule addition on the south elevation of the A-Wing.

There are aluminum storefront systems with brick bases that are not original to the building at both the north and south ends of the A-Wing. These are not character defining historical features. It is unknown when these additions were added; however, it is assumed to be within the past 20 to 30 years. They appear to be in fair condition; however, it is unknown if the systems are thermally broken. Since the additions are non-character defining historical elements, they could be removed and replaced with more energy efficient contemporary systems; or the original entries could be restored.

The aluminum doors and storefront systems are not original to the building. To return the entries back to their original appearance, the doors could be replaced with wood or a pre-finished hollow-metal or aluminum doors to match the historical appearance.

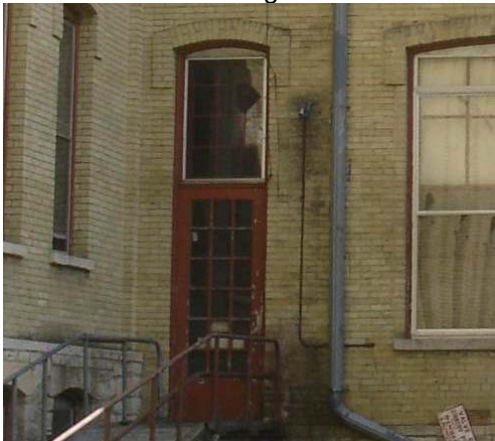
Original wood door and transom with an aluminum storm window above.

There is a variety of door types on the different wings of this building, ranging from wood to aluminum to painted hollow metal. It is assumed that the wood doors are original, based on the remaining paint color and the divided lite patterns matching the transom windows above. The wood appears to be in good condition, and may only need minor repair using wood consolidants or Dutchmen.

The existing wood doors are in fair condition. They should be repaired and refinished to match the historical appearance.

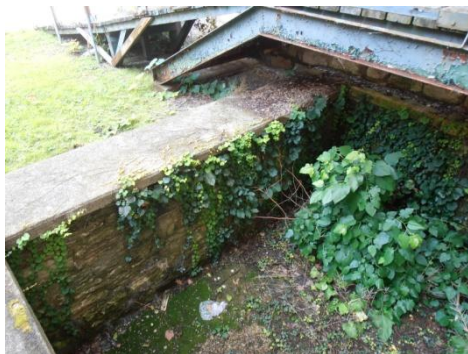
Picture #2:

Picture #2 shows the condition of an area-well at the south-east corner of the courtyard between Areas A and C. The condition of the retaining walls is poor and the presence of moss and vegetation suggests high levels of moisture.

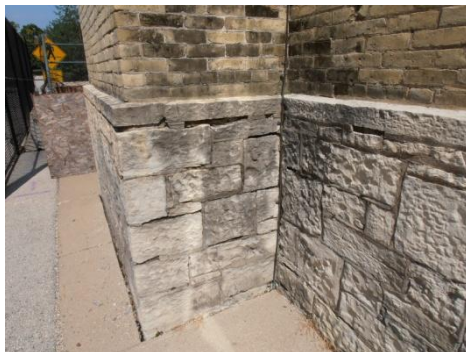
Picture #7:

The stone foundation walls are generally in good condition although they require repointing (or possible stone removal and replacement) in isolated locations – less than 1% of the total area. Pictures #7 and #8 show locations where the mortar is darkened in color and deteriorated or missing. In an attempt to prevent water infiltration to the basement and maintain overall structural integrity, repair of these conditions should be completed before the building is suitable for long-term preservation.

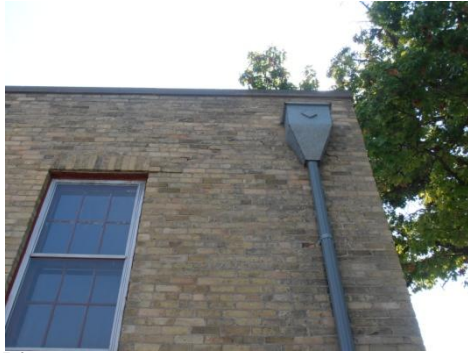
Picture #9:

There are isolated areas where the exterior brick shows significant structural cracking or some other form of deterioration that requires removal and replacement. Overall, the percentage of brick requiring these repairs is less than 1%.

Pictures #9, #10, #11 and #12 demonstrate that sections of failing brick occur most commonly in areas that are subject to gross water exposure. Picture #9 is taken at the north-west corner of Area C. Picture #10 shows the high roof at the south-east corner of the courtyard between Areas A and C. Picture #11 shows the southeast corner of Area C. Picture #12 is the high roof on the south side of Area B (above the Area C addition). Constant exposure to water, in conjunction with the repeated freeze-thaw cycles that are typical in this area of the country, leads to spalling of the face of the brick.

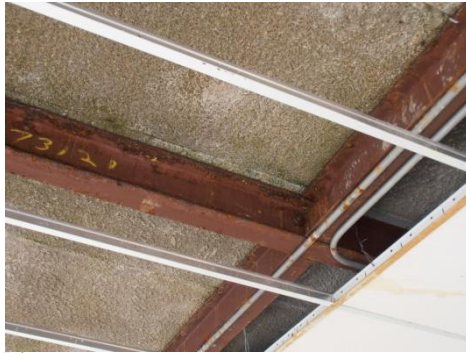
Picture #18:

Picture #18 shows the roof structure of the single-story covered entry area that provides access to the basement at the south end of Area A. The covered entry area was an addition to the original 1867 structure, although the exact date for the addition is not known. The roof structure appears to be precast concrete roof panels supported by steel framing. The steel framing shows signs of deterioration, particularly where the steel columns bear on a partial-height concrete wall (Picture #19). In order to ensure the integrity of this structure during long-term preservation, it would be important to inspect the members and connections for signs of deterioration, repair or replace damaged components and then protect the bare steel with a paint finish or other protective coating. As with all other areas of the building, it is important to inspect and maintain the roof drainage and all other building envelope components to ensure that the cause of the deterioration does not continue.

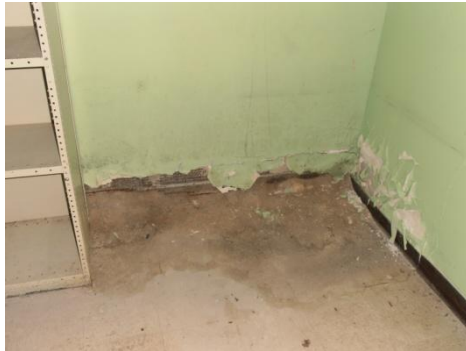
Picture #19:

Pictures #19 and #20 are taken in the basement and show signs of water infiltration; this is common. However, the pictures and other evidence observed in these areas do not suggest any significant underlying structural damage to the stone foundation walls. It is expected that a full destructive inspection may reveal miscellaneous structural defects – in varying degrees – but we expect them to be mostly minor issues such as repointing.

In order to secure the building for long-term preservation, we recommend that all the building envelope issues that are mentioned elsewhere in this document and in the Architect's report be addressed. Also we recommend that all site drainage issues be addressed. With envelope and drainage issues addressed, we expect active deterioration in the basement to lessen or cease altogether.

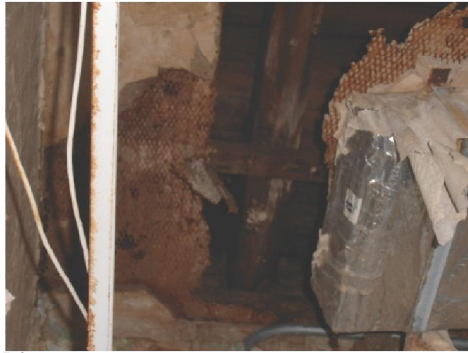
Picture #21:

Pictures #21 and #22 show isolated areas where damage to the floor structure above the first floor is visible (Picture #23 indicates the location of the photos). In general, the plaster is damaged more than the floor framing components in these areas. At most, two to three of the existing joists at each location may require repair or replacement. The cause of the damage is water infiltration. Because these conditions are adjacent to the exterior brick wall, one might assume there are nearby envelope issues. However, the water is not coming through the exterior brick wall at these elevations. The water is likely coming from higher floors. Both areas circled in Picture #23 have the same damage. It will be discussed at length in the sections that follow for the other floors, but the water appears to be entering two floors above where the nearly-flat upper section of the mansard roof (above floor three) joins with the top of the brick wall where it transitions to the upper mansard roof. This area of the roof is shown in Picture #32.

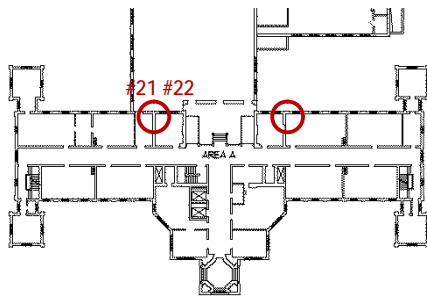
Picture #23:

Note that the locations outlined in Picture #23 coincide with areas of deterioration on the floor above. It should also be noted that severity of deterioration is worsening as we get closer to the source of water infiltration. In addition, being one floor higher, there are two additional areas of similar deterioration.

There are two causes of the gross water infiltration that is causing the damage outlined on Pictures #23, #27 and #31.

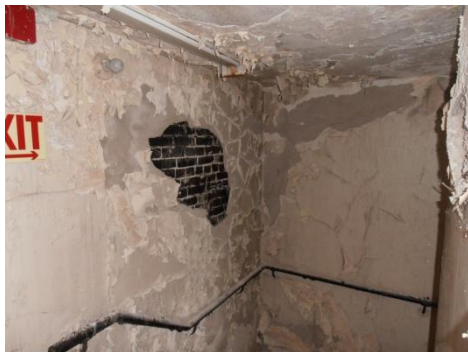
Picture #24:

Additionally, there is an area of severe deterioration at the north end of Area A concentrated at the main corridor and around the stairway. Deteriorated plaster is evident, in some cases down to the brick load-bearing walls, as shown in Picture #24. Mold and dampness are prevalent. The damage to this area of the building was caused by a roof leak at the top of the stairway; this will be discussed at length in the sections that follow for the higher floors. This damage is the most significant area of deterioration on the first floor. Beyond what can currently be viewed, we expect further damage to be present within the concealed areas of framing. Detailed recommendations for necessary repairs to this area are beyond the scope of this document. Fixing the roof leak to prevent further water infiltration is most critical to prevent the condition from worsening.

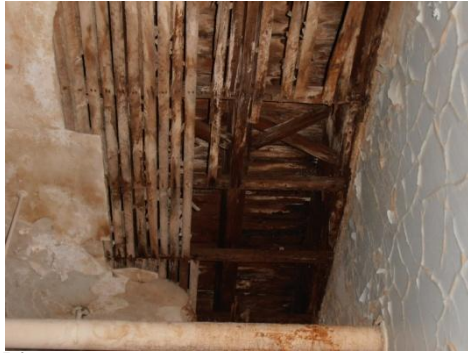
Picture #25:

Pictures #25 and #26 show areas of isolated damage to the floor structure above due to water infiltration. Locations for this isolated damage are indicated in Picture #27. Additional areas of similar concentrated damage are also shown in Picture #27. Again, the source of this damage is the nearly-flat upper section of the mansard roof (above floor three) where it joins with the top of the brick wall where it transitions to the upper mansard roof (see Picture #32).

Exact damage to floor framing and wall studs in these areas is unknown, but it is to be expected that removal of components and replacement will be necessary in order to ensure the integrity of the building during long-term preservation. Even more important, though, is to repair the envelope failures that are allowing water to enter the building.

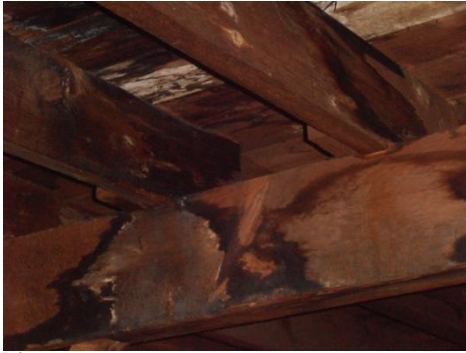
Picture #28:

There are many small leaks in the flat portions of the mansard roof above the third floor north and south wings. One such leak is shown in Picture #28 (taken from the shallow attic area beneath) with associated damage to the roof decking and framing below. The damage is minimal, however, primarily because the water is able to drip freely to the ceiling structure which is 3' to 4' below. Thus, much of the damage is sustained in the lathe and plaster – an example of which can be seen in Picture #29.

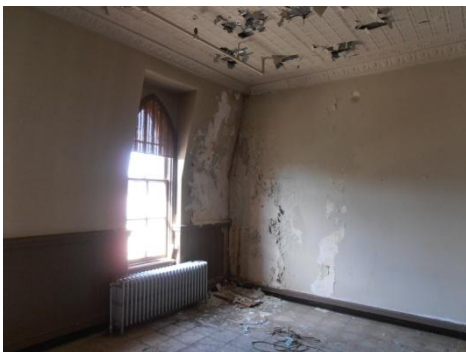
Picture #30:

Picture #30 shows an area of isolated damage to the roof structure above the third floor – although it is more difficult to see the damage because of the metal panel ceiling. The location is identified on Picture #31. Picture #31 also shows other areas of isolated damage that coincide with the damage that was seen on the floors below.

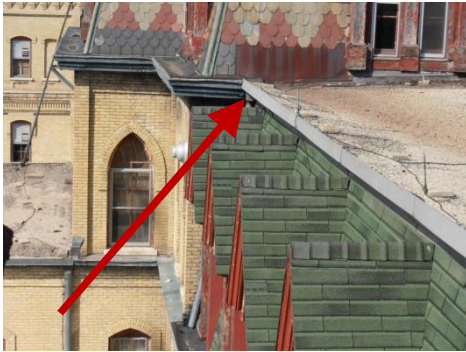
Picture #32:

The first cause, that has been mentioned earlier, is a massive failure of the flashing and gutter/downspout system where the mansard above the third floor north and south wings joins to the top of the brick walls at the central core area. One such area is shown and pointed out in Picture #32 (location shown on #31).

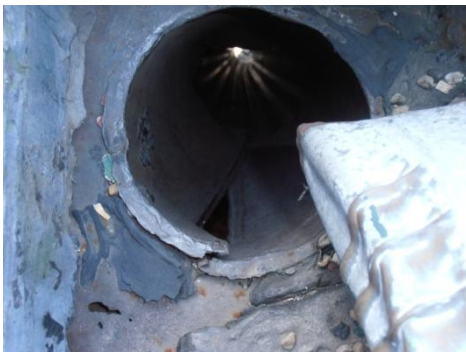
Picture #34:

Picture #34 is taken inside one of the roof conductors, where it can be seen that large gaps in the conductor are allowing water to penetrate into the framing below. Exact damage to the framing in these areas is unknown, but it is to be expected that significant removal and replacement will be necessary in order to ensure the integrity of the building during long-term preservation.

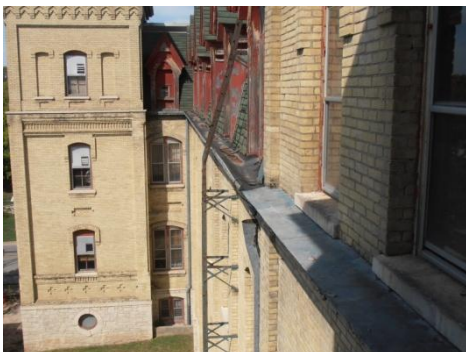
Picture #35:

The general condition described in #32, #33 and #34 (actually occurring in four locations) is the primary cause of the gross water infiltration that has been described above. The second cause is the drainage trough that can be seen in Picture #35 at the base of the mansard roof. The location of the photo can be seen in #31. In the center of the photo, it can be seen that the rubber-roofed drainage trough terminates where the mansard ends and the brick begins. There is a roof conductor at this location but much of the flashing is badly deteriorated.

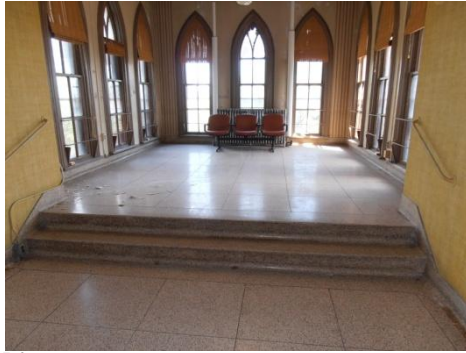
Picture #36:

As on the second floor, the third floor room that occupies the footprint of the central tower has a floor that is bouncy and demonstrates poor vibration performance (Picture #36). As with the second floor space, this seems unusual and it is not known if this is a design and construction error or the result of deterioration. We recommend that the framing be investigated from the underside to determine if this warrants additional attention. This doesn't need to be completed before long-term preservation, but should be completed before the building is opened to the public.

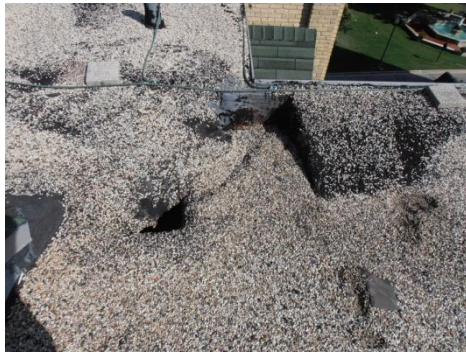
Picture #37:

At the north end of the building just off the main corridor, above the stairway, is the source of the water infiltration that caused the most severe damage to the building. The small hole in the roofing is shown from the top side in Picture #37 and from the underside (within the stairway) in Picture #38. A partially successful fix was provided involving a water collection device and a rudimentary drainage basin and drainage system that exited through one of the third floor windows. It is not known if the system is still functioning, although there was still water in the basin.

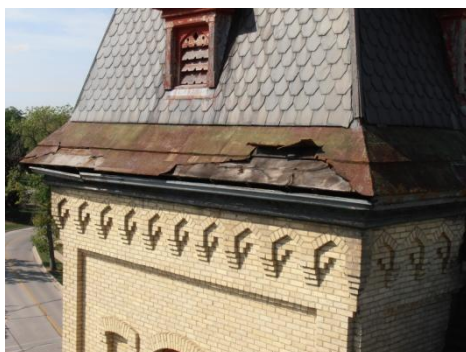
Picture #39:

Picture #39 shows the typical condition of the lower flashing at each of the four corner towers. Picture #40 shows the condition from the inside of one of the towers. The flashing and roofing need to be repaired to make the structure weather-tight and to eliminate the pigeons that are living in the towers. Significant deterioration to the wood framing was not noted and replacement of wood members will not likely be necessary if the problem is addressed soon.

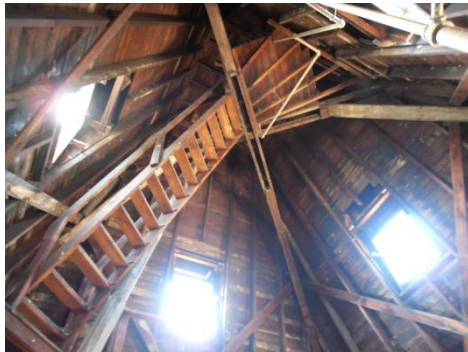
Picture #41:

Picture #41 shows the framing and wooden ladder that is typical inside each of the towers.

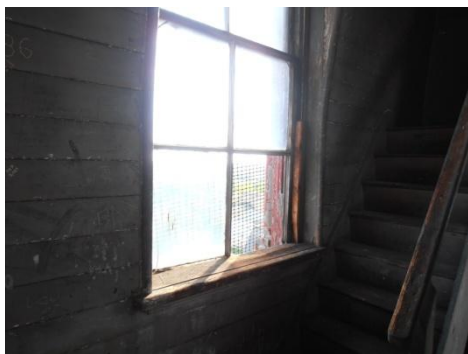
Picture #43:

The central tower is in fair condition. Both the brick portion that extends up to the base of the mansard roof and the mansard roof itself show no signs of significant structural distress. As shown in Picture #43, many of the windows have broken or missing panes of glass. These should be repaired, although it appears that the black protective netting may be keeping the pigeons out for the time being. The floor in some areas appears to be spongy, possibly because of the water infiltration, but otherwise the wood structural components appear to be in fair condition.

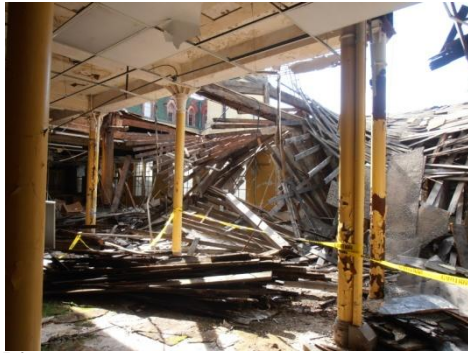
Picture #44:

This portion of the building has experienced several instances of structural collapse at both the first and second floor. These collapses were caused directly by the systemic and long term failure of the exterior building envelope, including roofing, flashing and masonry walls. This failure exposed the load carrying wood structure to gross moisture damage. Over time the wood has rotted to the point where it is no longer capable of carrying the necessary load. The result is evident in Picture #44 and Picture #45.

A repair project is currently underway that directly addresses the currently collapsed portions of Area B. However, there are additional portions of Area B that are experiencing structural distress.

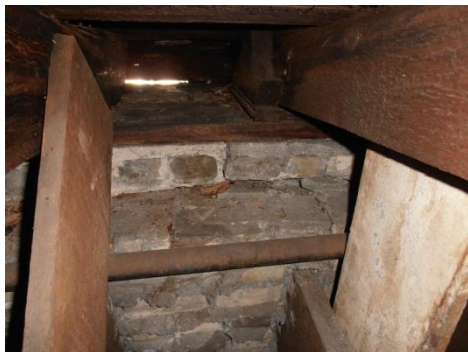
Picture #47:

Pictures #47 and #48 show the condition at the east and west sides of the westernmost portion of the second floor roof. Both these pictures show an on-going failure of the brick masonry wall at the rafter/brick wall connection. The interior wythe of the brick wall is cracked along most of the 30' length of the wall, and the portion of the wall immediately above the crack and below the sill for rafter bearing is rotating outward. This support failure is causing the ridge rafter to sag, and will eventually result in a partial roof collapse. In typical roof construction, the outward thrust of the shallow ridge rafters is resisted by a tension member. In this case, that member is located almost 12" below the bearing point. The connection between the rafter and the tie is at such a steep angle that it is not providing the necessary lateral resistance. The problem is made worse by the deterioration of the roof, and subsequent water infiltration – daylight can be clearly seen in Picture #47.

To completely repair this area it will be necessary to remove and replace significant portions of the roof deck, move the rafters back

into their proper position, remove and repair the brick masonry for at least the first two courses below the sill, repairing the sill as required, and providing functioning tension ties for at least every other rafter set. This repair work will be necessary for the entire 30' length of the upper roof. If historic preservation considerations will permit, an alternative repair is to simply remove the roof and replace the current rafter-ridge beam system with a modern gang-nail truss system. This will still necessitate a repair of the brick masonry, but may be otherwise less expensive.

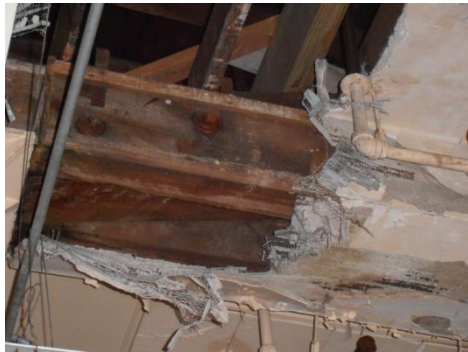
Picture #49:

Picture #49 shows a rotating and deflecting roof support truss located on grid line 12. This is the eastern most truss in the first floor roof structure. Because of peculiarities of the roof framing, this truss carries 20-25% more load than the rest of the trusses at this level, though all trusses appear to be constructed identically. There is no readily apparent sign of moisture deterioration, though much of the bottom chord of the truss is concealed, and the connection at the exterior wall cannot be readily explored. However, this truss has clearly sagged to a substantially greater degree than any of the others, and has rotated significantly at the interior support. Without repair or replacement it is likely that this truss will eventually fail, particularly under a heavy wet snow load. We estimate that the repair/replacement of this element would involve the shoring or replacement of almost 1000 square feet of roof area

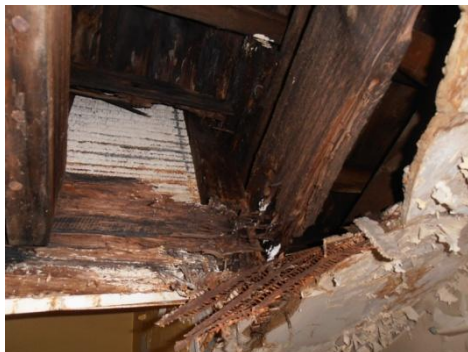
Picture #50:

Picture #50 shows rotted and deteriorated framing associated with the skylight framing, located just east of the truss noted above. While much of the skylight framing is in acceptable condition, the south end at the exterior wall has undergone considerable deterioration from water penetration through the roof, and around the skylight system. Framing in this area will need to be replaced. We estimate that approximately 150 square feet of roofing and roof framing will require replacement.

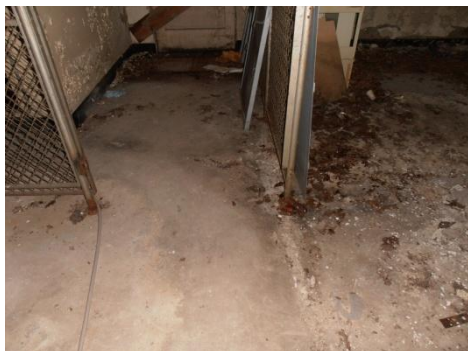
Picture #51:

Picture #51 shows cracking and heaving that has shown up in the basement level slab within the past year. We attribute this to the lack of heat and subsequent freezing in the basement area, and the excessive moisture to which the building has been subjected over the last two years. We estimate that there are currently 50 linear feet of crack that should be routed out and grouted. However, as Picture #42 clearly shows, the presence of gross quantities of water in the building at the present time, and the inevitable saturation of soil sub-grade through cracks in the flooring and at the floor wall juncture may well increase the quantity of crack repairs significantly.

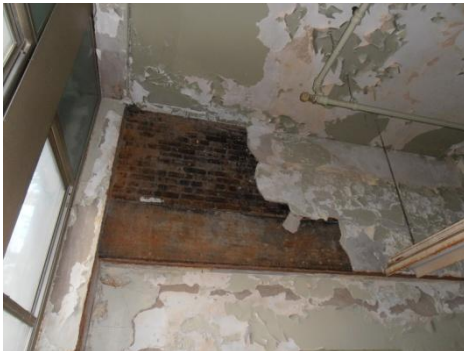
Picture #54:

The perimeter walls are load bearing brick, supported on the north and south sides by a concrete beam spanning between exterior walls and interior columns, as shown in Picture #54. The first floor is supported by a cast-in-place concrete pan joist system shown in Picture #55, spanning between concrete girders which are in turn supported on concrete columns. The concrete structure appears to be in good condition, with no visible spalls, reinforcing steel exposure or corrosion/rust. Given the exposure to ambient moisture clearly evident in many areas of the basement level and first floors, and the condition of the structure visible in these photos, we believe it is likely that the structure throughout will be in a similar condition.

Repairs in the interior of this area of the building are expected to be limited to incidental small areas that may require concrete patching, and some very limited brick replacement.
